NESTOR HOME INSPECTIONS

HOME

6 Zoar Ave
Albany, NY 12203

JANUARY 1, 2025

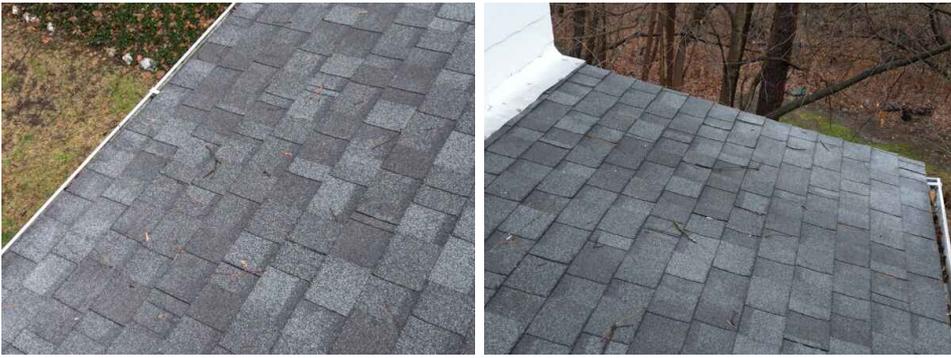
2.8.2 General Observations

DEBRIS

Several areas of the roof have branches, pine needles, leaves, or debris sitting on it. This could allow for water to rest on the roofing material for an extended period of time. Damp areas could encourage moss or algae to form. Over time, this may shorten the life of the roofing material. Recommend routine cleaning of debris off the roof.

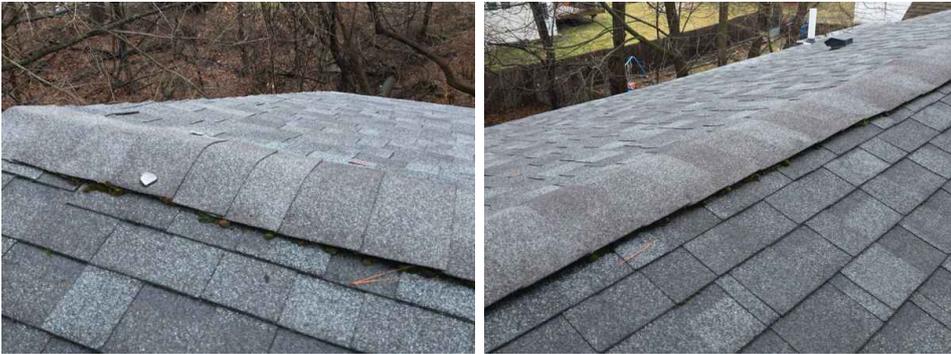
2.8.3 General Observations

MOSS/LICHEN

Moss/lichen noted on the roof. This can lead to deterioration of roof decking due to water being leached under the roofing materials by the moss/lichen. Recommend a qualified contractor repair as necessary.

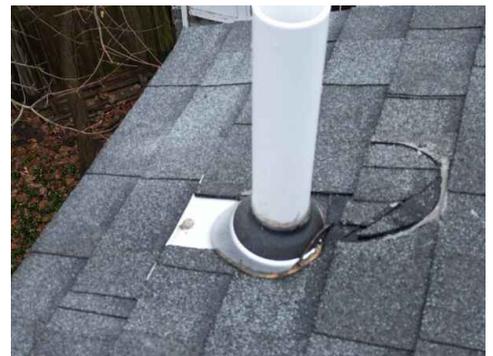
2.8.4 General Observations

OLD REPAIRS

An area of the roofing shows old repairs. Areas have begun to crack and lift. This may allow water into these gaps. Recommend a qualified contractor repair as necessary.

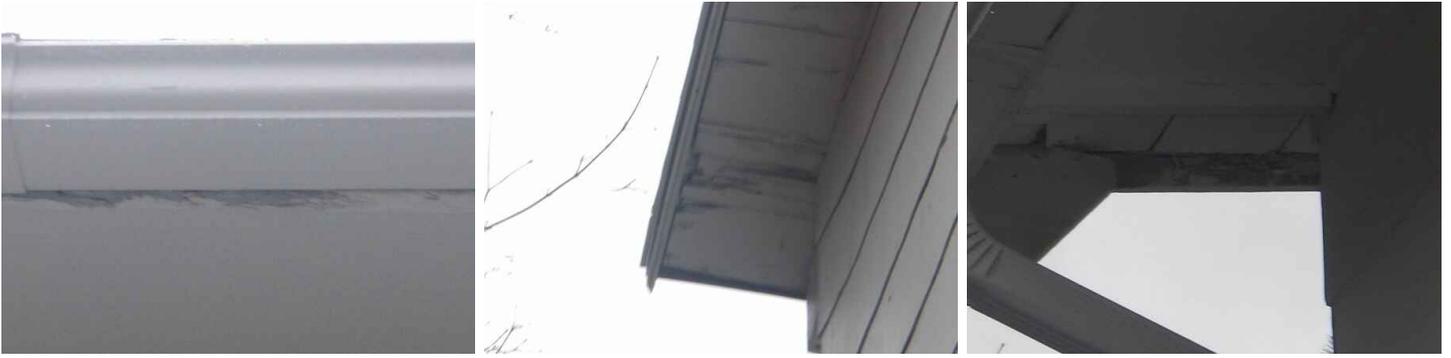
2.8.5 General Observations

PAINT

An area of the fascia/soffit has curling, chipped and missing paint. This is exposing bare wood to the elements of nature and will cause the wood to rot. Recommend scraping and painting said areas to prevent further exposure.

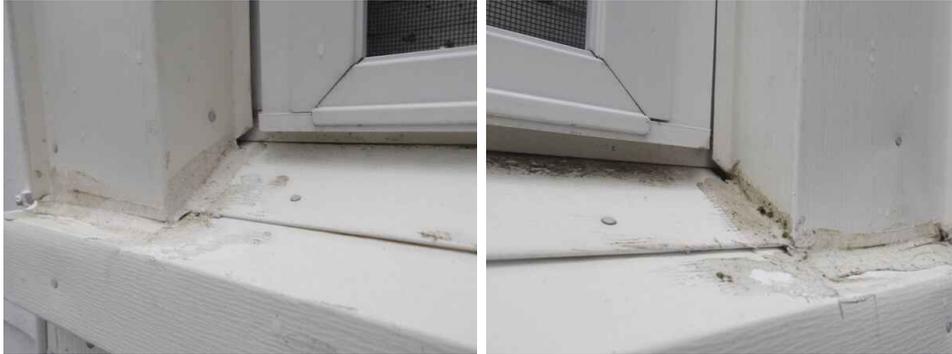
Several areas of the siding have wires, pipes, or punctures that require sealing. These areas could allow water or insects to enter the sheathing of the house. Recommend contacting a siding contractor.

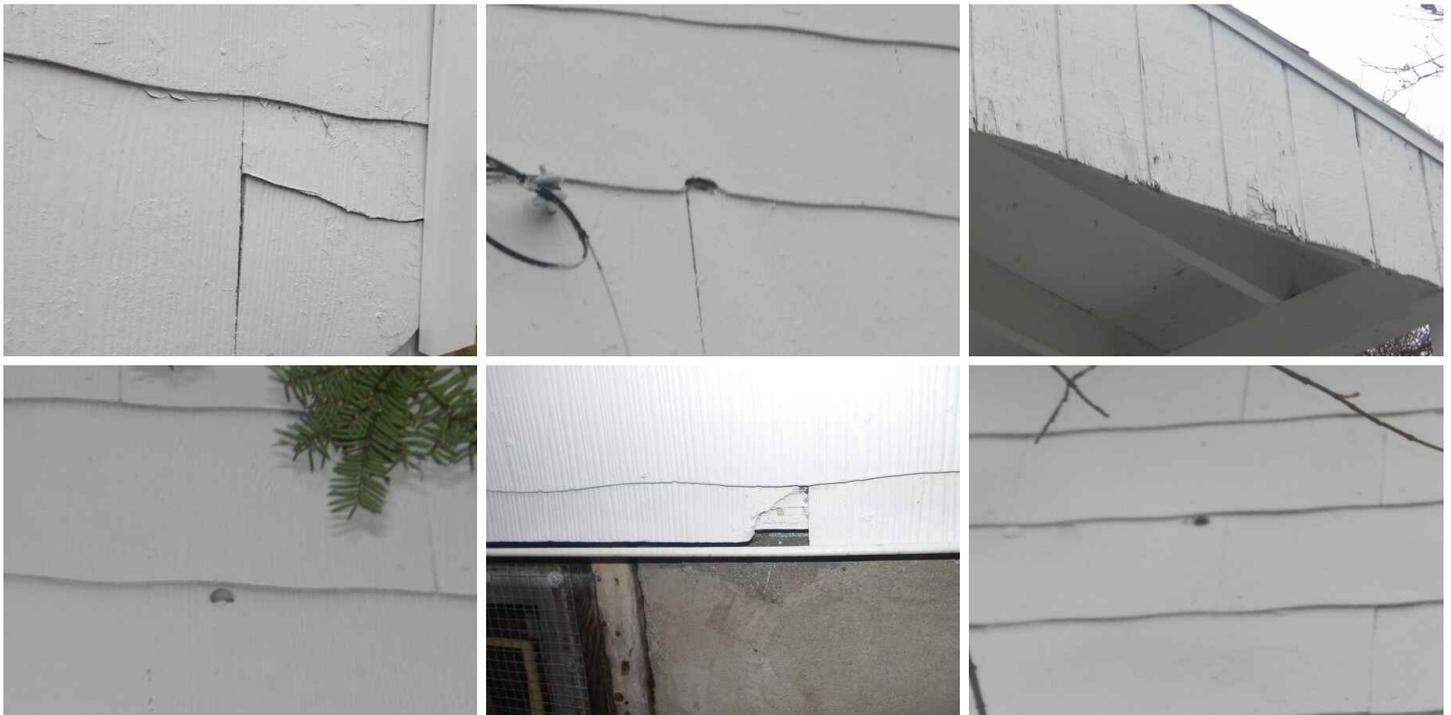
4.15.3 General Observations

Siding is damaged in an area of the exterior. A siding contractor should evaluate and make repairs and/or replace siding as necessary to prevent water and insect intrusion.

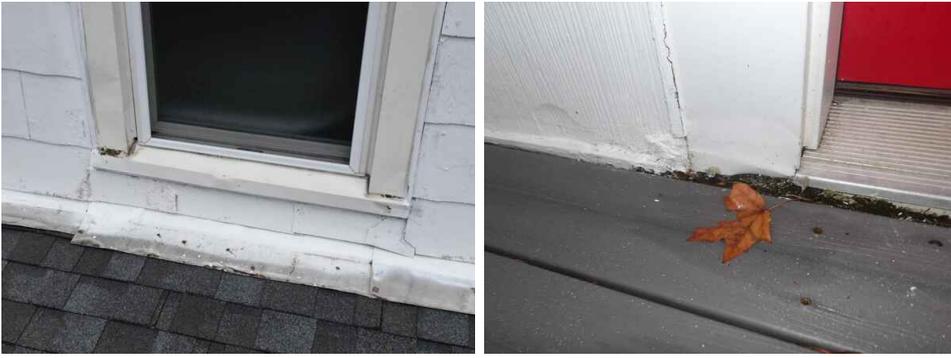
4.15.4 General Observations

Wood trim shows signs of deterioration. This creates an area that is conducive to wood destroying insects. Recommend contacting a building contractor to repair as necessary.

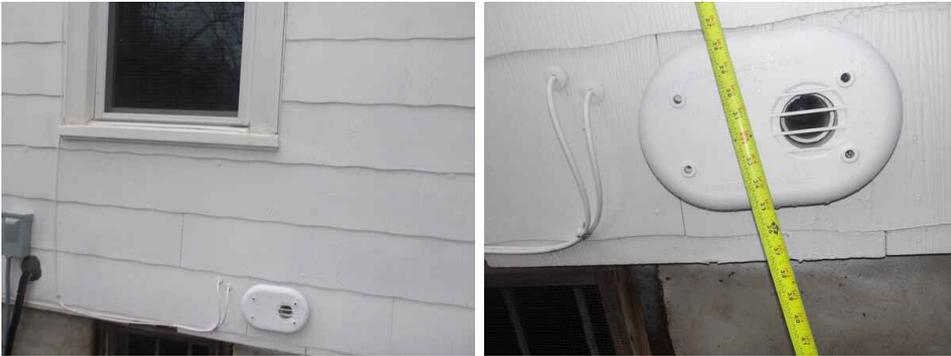
4.15.5 General Observations

The exhaust pipe is not installed using standard building practices. This could allow exhaust from the appliance to enter the house. Standard building practices terminate the pipes 4 feet from a window or door opening. This is a safety concern. Recommend contacting a heating contractor to repair.

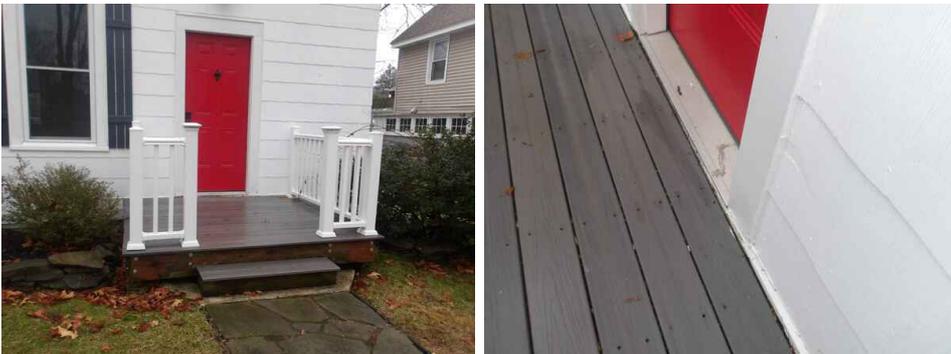
4.15.6 General Observations

There is no flashing installed in the area where the entry area attaches to the house. Flashing is a preventative measure that stops water from entering the house. If water can penetrate into the house framing it can result in mold or deterioration of the framing. Recommend contacting a building contractor.

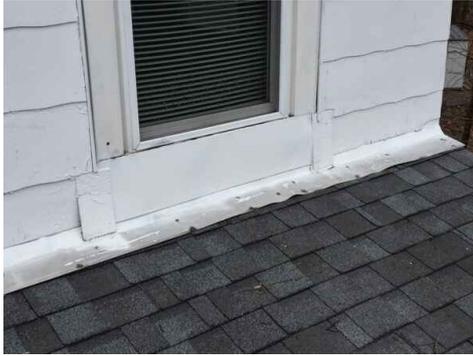
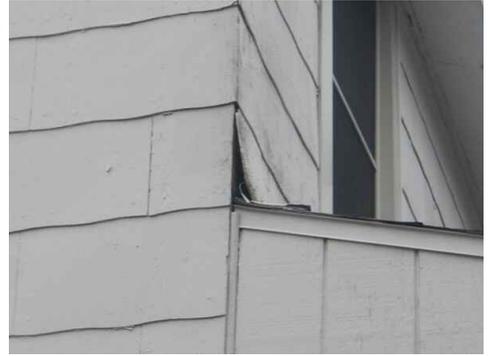
4.15.7 General Observations

An area of the house has loose siding. This area could allow water or insects to enter the sheathing of the house. Recommend contacting a siding contractor to repair as necessary.

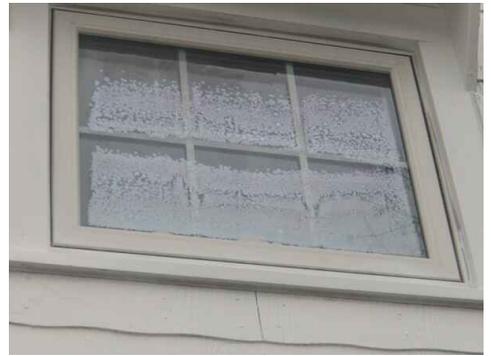
4.15.8 General Observations

Low E (emissivity) glass is actually a coating put on one of the inner surfaces of the glass to save energy, either by keeping the sun out of the home in the summer or keeping the warmth of home from radiating out of the home in the winter. In some cases, as the window ages, the coating may deteriorate. The signs of this failure may appear as small round spots to an entire window pane having a metal looking tint. Recommend contacting a window contractor to repair.

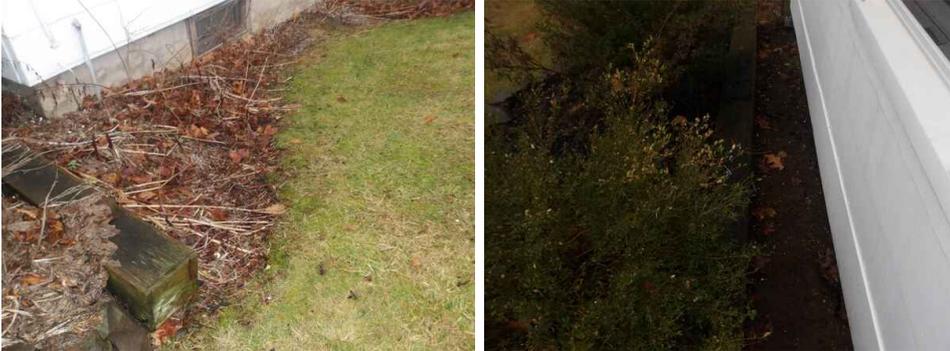
5.14.2 General Observations

There was a depression next to the foundation. This could allow water to sit next to the foundation. Water that sits next to the foundation could enter the house and impact this area over time. Recommend contacting a qualified contractor to improve the grading next to the house.

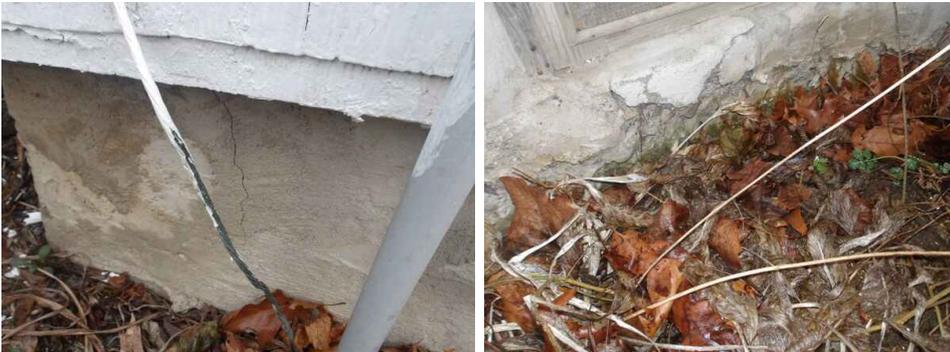
5.14.3 General Observations

Foundation masonry veneer has small cracks or deteriorated surfaces. This can allow moisture to penetrate the foundation and cause deterioration. Recommend contacting a mason contractor to evaluate and repair as necessary.

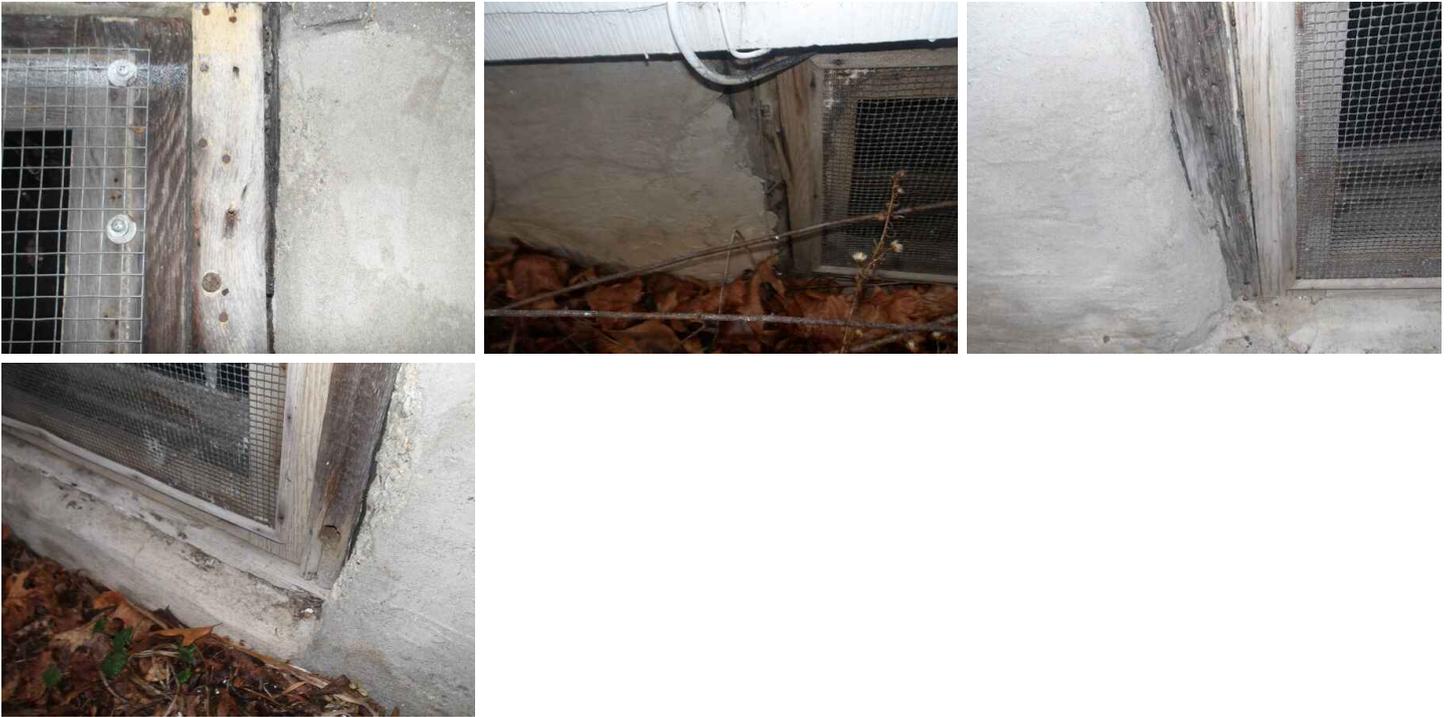
5.14.4 General Observations

An area of porch/deck/patio, trim, or windows have curling, chipped or missing paint. This is exposing bare wood to the elements of nature and will cause the wood to rot. Recommend scraping and painting said areas to prevent further exposure.

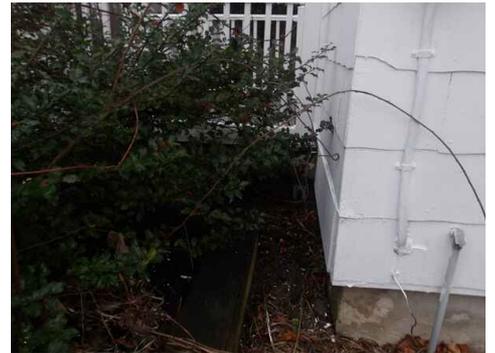
5.14.5 General Observations

Shrubs and trees are in contact or very close to the siding. Continued moisture on the siding could lead to moss or mold build-up. These areas create easy access points for insects to enter the house. Recommend pruning or moving shrubs so there's at least a one foot gap between shrubs and siding.

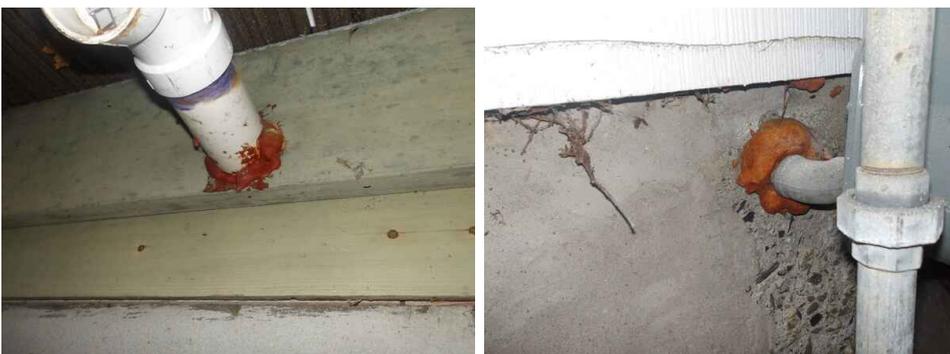
5.14.6 General Observations

An area of the the exterior is sealed with foam insulation. Foam insulation left directly exposed to the sun and weather will begin to deteriorate. This will encourage insects and water to enter the house. Recommend contacting a qualified contractor to repair as necessary.

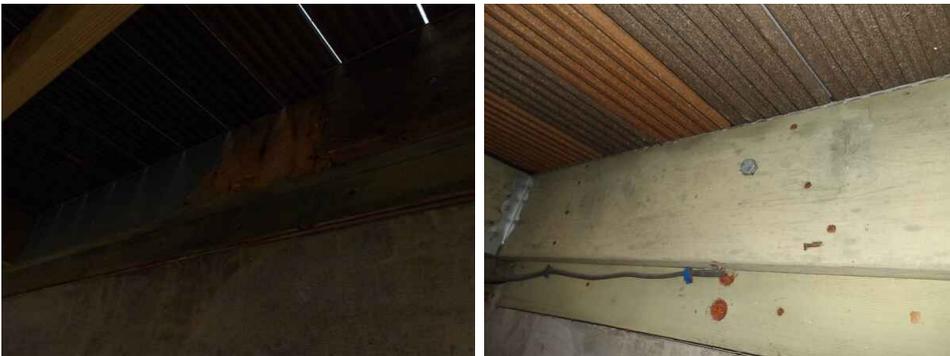
6.17.3 General Observations

LAG MISSING WASHER

The entry area was lagged into the house with lag bolts, but they were missing the washers. The use of washers and lag bolts is a better fastening system and is standard building practice. Recommend contacting a general contractor to repair. The entry area was secure at the time of the inspection.

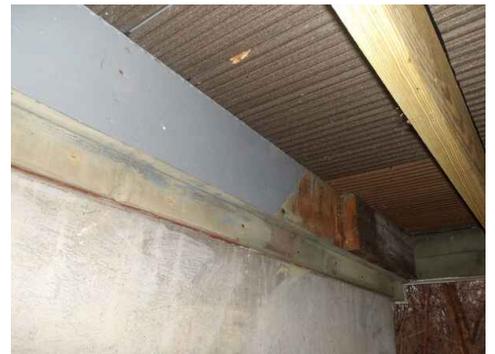
6.17.4 General Observations

PORCH/DECK ATTACHED WITH NAILS/SCREWS

The porch/deck is attached to the house with nails in the ledger board. The use of lag bolts or structural screws prevents the porch/deck from separating from the house and is the common building practice. Recommend contacting a building contractor to repair. At the time of the inspection the porch was secure.

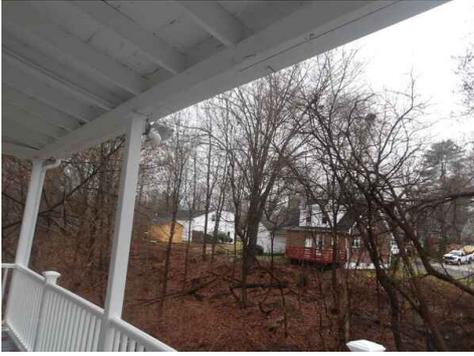
6.17.5 General Observations

SWAY BRACING

The diagonal sway bracing was not noted. This bracing keep the deck/porch/patio from moving. Recommend contacting a general contractor to install the supports. The deck/porch/patio was stable at the time of the inspection.

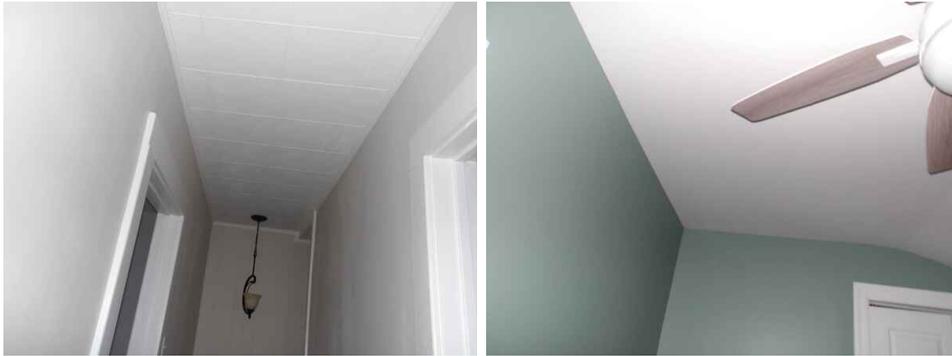
No access hatch was found into the attic. I was not able to evaluate the attic, and it is excluded from this inspection. Recommend having a building contractor install access hatches as necessary to allow for periodic evaluation of attic spaces.

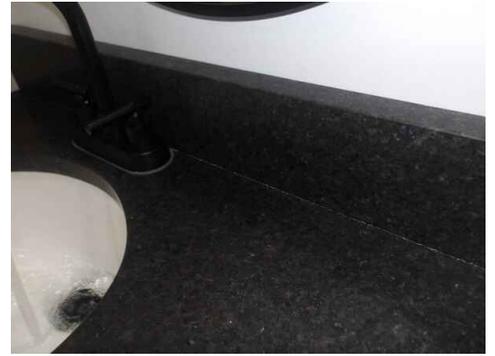
Noted missing caulk in the bathtub/shower/sink area. This could allow water penetration to the underlayment or vanity. Recommend a qualified contractor repair or replace as necessary.

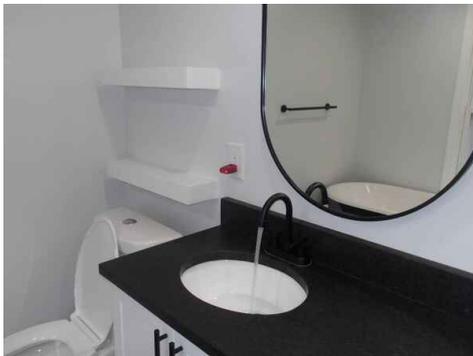
9.16.3 General Observations

GFCI NEEDED

No ground fault circuit interrupter (GFCI) outlets installed. GFCI outlets help prevent electric shocks in areas that may have water present. Recommend having a qualified electrician install one or more GFCI outlets, especially over counter tops and around sinks.

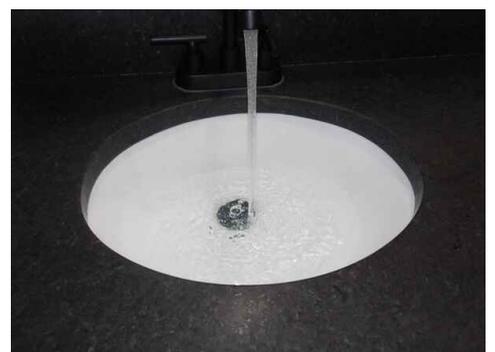
9.16.5 General Observations

SINK DRAINS SLOW

The sink drains slowly. The most common reasons for a slow drain are clogs or improper venting. Recommend a plumber evaluate and repair as necessary.

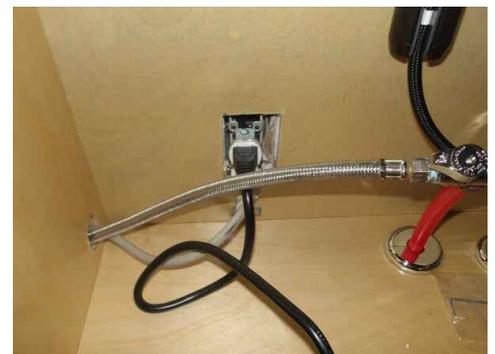
Exposed wiring due to splices not being contained in junction box or missing a cover plate. Recommend having a licensed electrician install junction boxes with cover plates where needed to contain wiring splices.

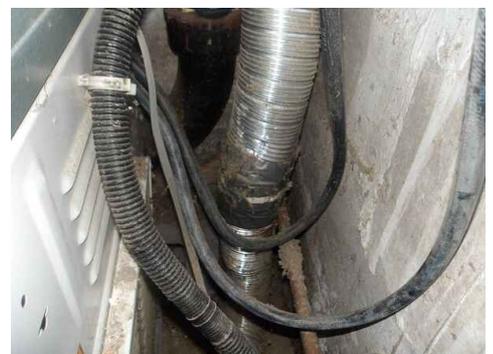
Duct tape adhesive fails under the extreme temperatures. For dryer vents and HVAC ducts, you should seal seams with a foil backed tape. This is designed to be airtight and handle the temperature swings that would cause other types of tape to fail. Recommend contacting a qualified contractor to repair as necessary.

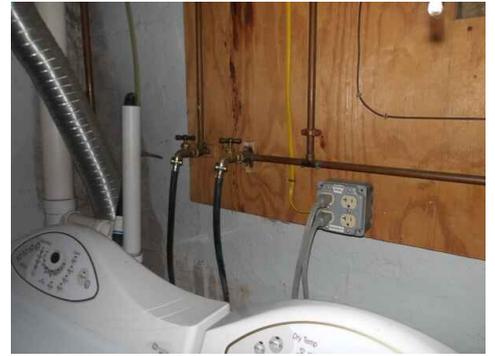
12.10.3 General Observations

The supply lines/discharge lines for the washer and electrical outlet are in close proximity. If the supply line were to leak, water could come in contact with the outlets. Recommend contacting a qualified contractor to repair.

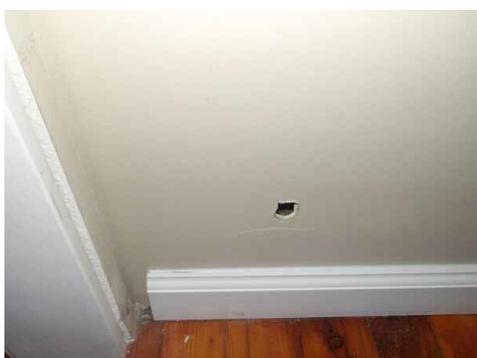
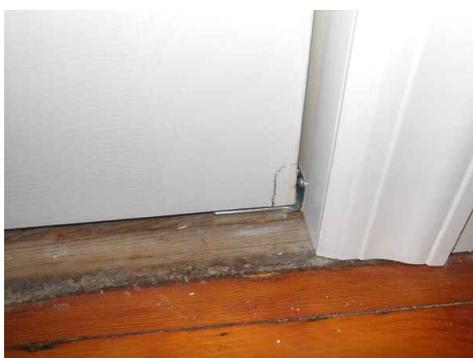
An area of the general interior is damaged. This is a cosmetic defect. Recommend contacting a qualified contractor to repair.

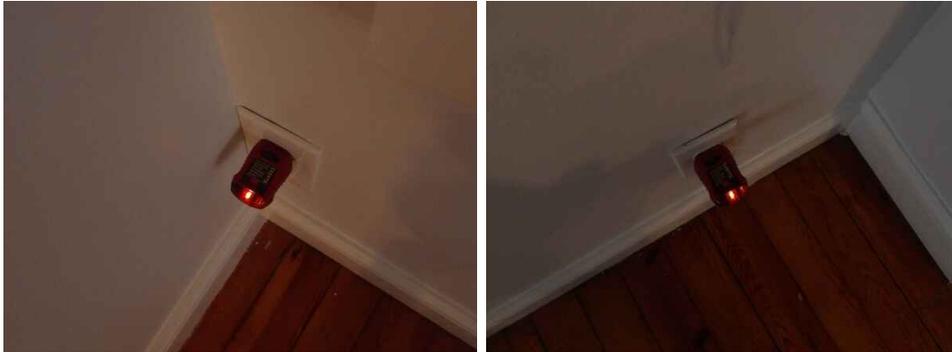
13.16.5 General Observations

One or more open ground outlets. Grounding protects by limiting the possibility of damage to electrical equipment and preventing shocks to people. Recommend contacting an electrician to correct the wiring.

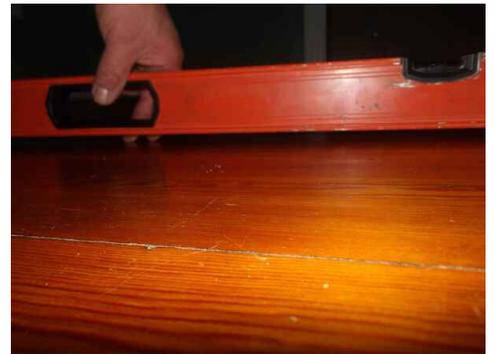
13.16.6 General Observations

Over time houses may settle and move. This can be seen in the floors, walls, and entry ways. House settling is a natural process in which a building gradually sinks into the ground over time. As the soil beneath the foundation begins to shift, a home slowly sinks downwards into the earth. This may not indicate a structural deficiency, but a natural evolution of a home. Recommend monitoring the home for future movement. Repair as necessary.

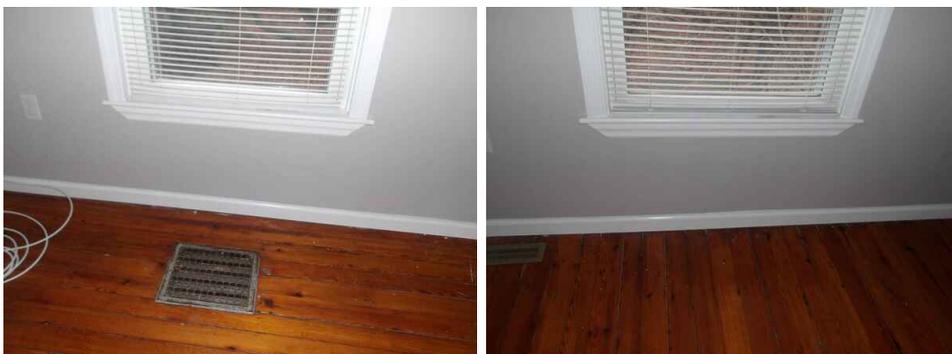
13.16.7 General Observations

A window of the house has a bottom sill that is close to the floor. This is a safety concern. Recommend installing safety guards so pets or individuals may be able to fall out the window.

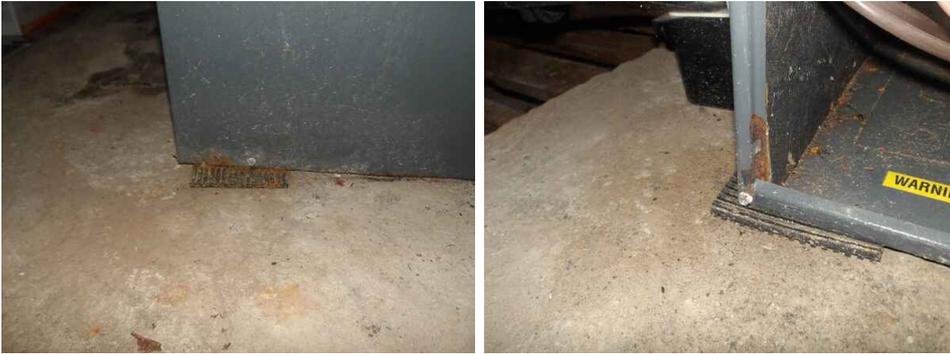
14.20.2 General Observations

Rust was noted on the furnace/boiler. The source of the water needs to be identified and repaired. Recommend contacting a heating contractor to repair as necessary.

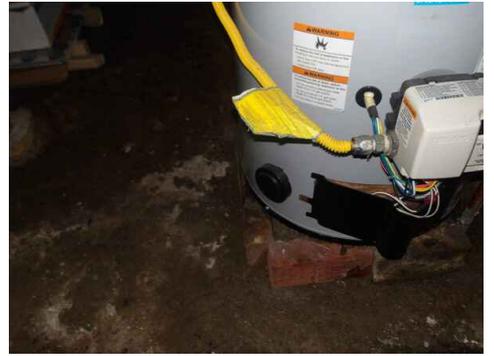
16.17.2 General Observations

Gas line to hot water heater does not have a drip leg. This collects impurities in the gas to insure proper fuel burn. Without a drip leg, the impurities will create blockage in the fuel line leading to early unit failure and inefficient operation. Recommend a qualified contractor repair as necessary.

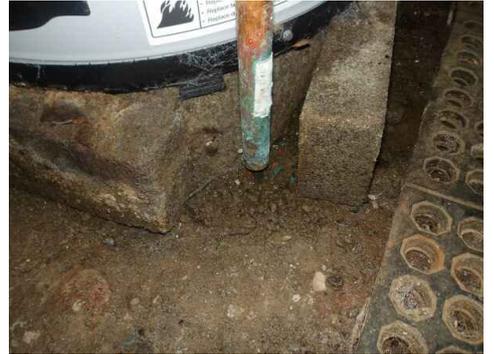
16.17.3 General Observations

Temperature-Pressure relief valve appears to be leaking. This can indicate an early sign of failure. Recommend a qualified contractor repair or replace as necessary.

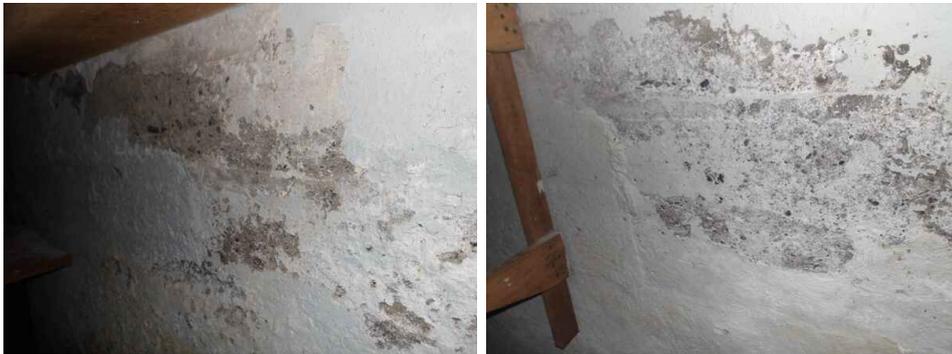
Efflorescence is a salt and mineral deposit on surfaces of masonry, stucco or concrete. It is whitish in appearance. The cause is from the movement of groundwater into a buildings foundation by capillary action, wicking, or hydrostatic pressure. Recommend installing gutters and improving the exterior grade to keep water away from the basement.

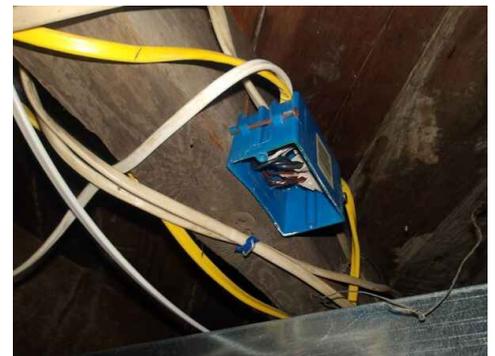
20.21.4 General Observations

All wire connections should be made in a junction box with a cover plate. Having an exposed wire connection is a safety concern. Recommend contacting an electrician.

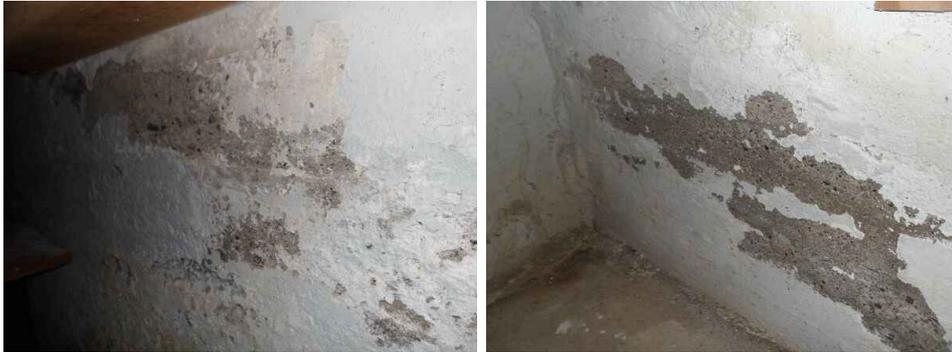
20.21.6 General Observations

Spalling has occurred on the face of the wall. The cause of spalling of a foundation wall is usually, but not limited to, concrete blocks absorbing water from wet soil against the outside of the foundation. Recommend making sure water is removed from the exterior of the foundation wall. Contact a mason as necessary.

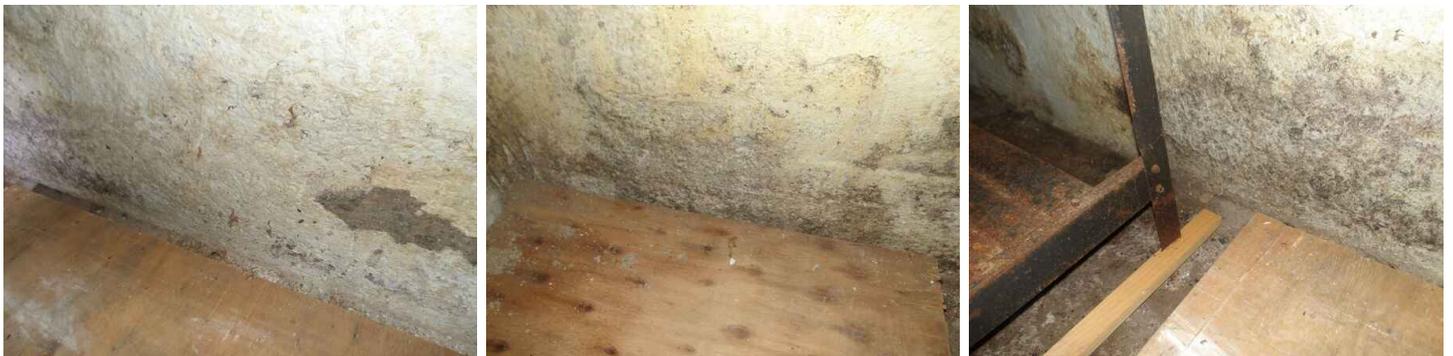
20.21.7 General Observations

An area of the basement had mold like substance. Mold grows in areas that continually have moisture. The source of the moisture needs to be identified and repaired. These areas should be treated by a qualified contractor.

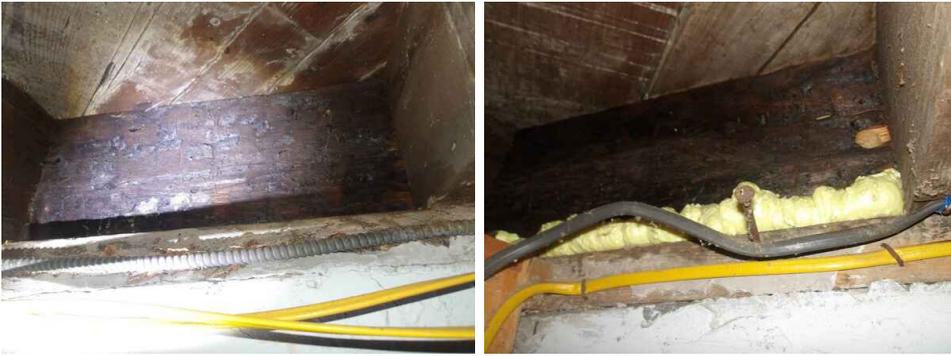
20.21.8 General Observations

It appears that a fire had occurred at some point. The areas appeared to be stable at the time of the inspection. Recommend contacting current owner about any previous fires. Recommend contacting a qualified contractor to evaluate damaged areas.

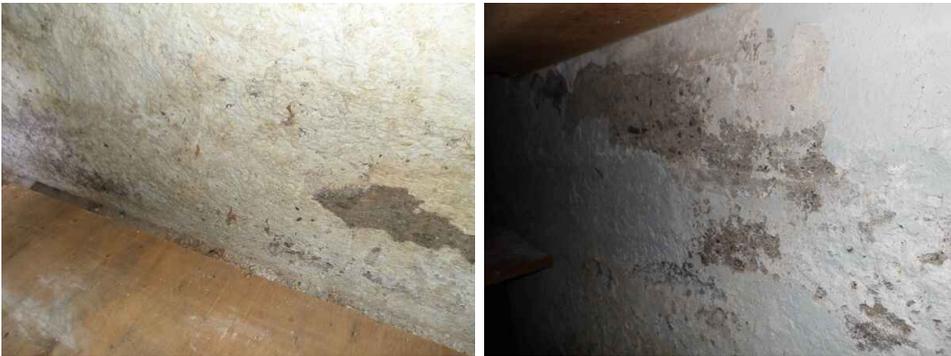
20.21.9 General Observations

Some signs of moisture were noted on the foundation walls or floor. Recommend gutters with extensions be installed on the house or grading improved to keep water away from the foundation. Recommend contacting a qualified contractor.

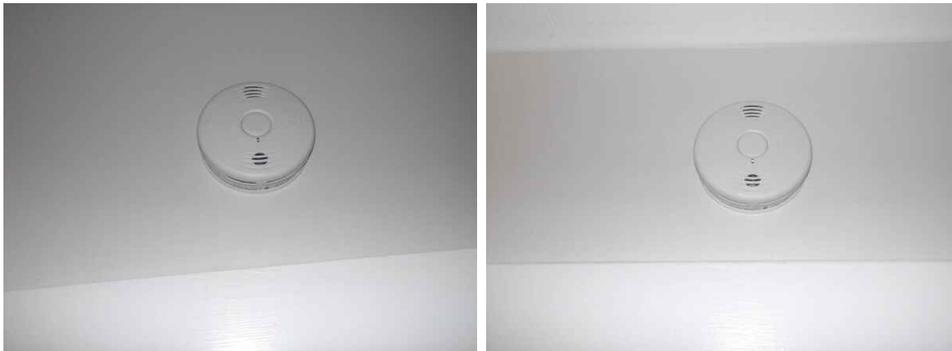
Smoke alarms and carbon monoxide detectors should be replaced when they are in service longer than 10 years. Since we don't know the age of the existing alarms they should all be replaced. Additional smoke detectors should be installed as necessary in each hallway and bedroom. For more information on smoke detectors visit <http://www.cpsc.gov/cpsc/pub/pubs/5077.html>
